PRS8

The LUCAS PRS8. Why is this switch is apparently so involved. First you have to remember that they were designed and originally made in the 1950s so the fact that some of originals are still doing good service does say something for their manufacture. There are two layers, the upper for lights and the lower for ignition. As of course they were built to control the early 6V Lucas alternators. It isn't a case of just switching the ignition on or just putting the lights on. First the ignition layer, this has a normal ignition position, switching DC to the ignition coil. Then an emergency position which incorporates AC as well. In the EMG position it must reconnect the full output of the alternator (which was previously only partly being used.) so that is the second function. Then due to the fact that when these switches were first made, rectifiers were made with SELENIUM, these weren't very efficient as rectifiers and used to leak badly, your battery could go flat quite quickly. So the switch used to switch the rectifier away from the battery, a third function.

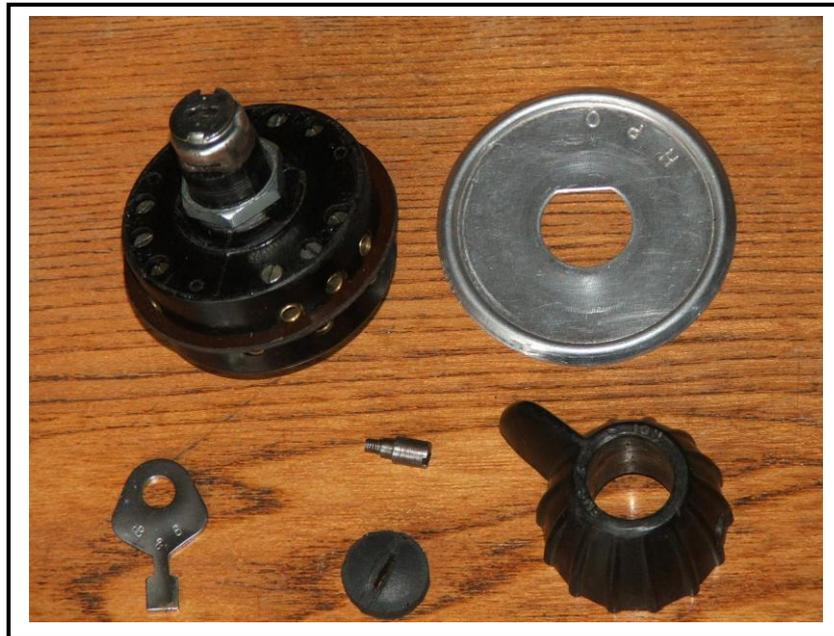
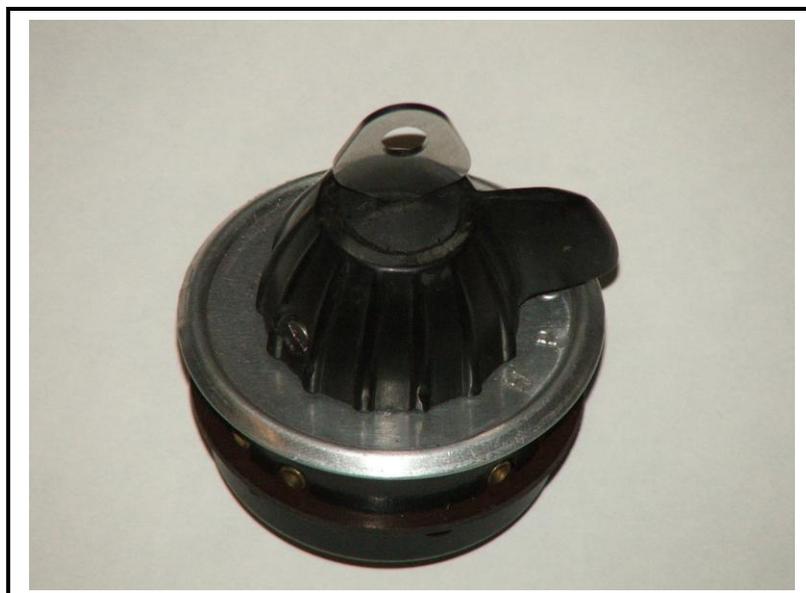
The parts:-

‘A fine set or parts you will come across, the key is the right one as it fits the ignition spindle and the key security tab.
